Manhole Inspection Summary

Manhole # S21C1_008MH

Insp Date: **5/19/08 2:50 PM**

Location Address: **2500 ridgely st**

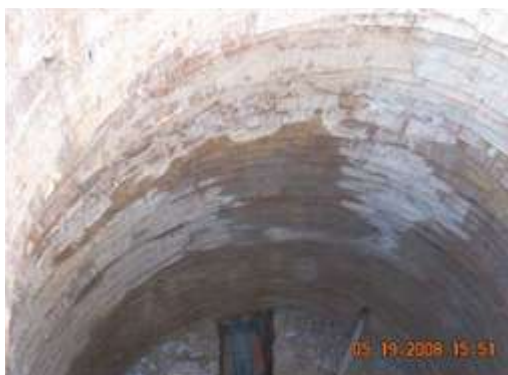
Defect 3

Infiltration: ☐ None ☐ Joint ☐ Cracks ☐ Mortar ☐ Roots ☒ **Wall**

infiltration @ barrel wall, bench debris

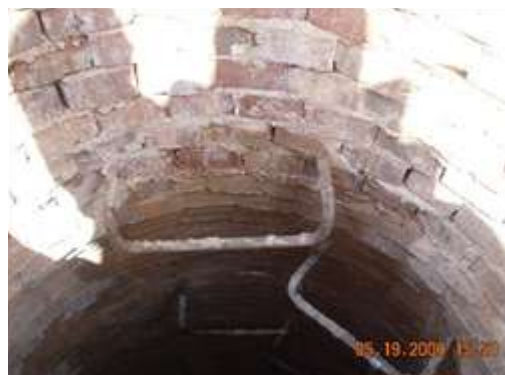
Defect 2

Condition: ☐ Sound ☐ Cracked ☐ Root Intrusion ☒ **Loose Brick** ☐ Deteriorated

Infiltration: ☐ None ☐ Joint ☐ Cracks ☐ Mortar ☐ Roots ☒ **Wall**

loose bricks and infiltration @ corbel wall, from step anchor

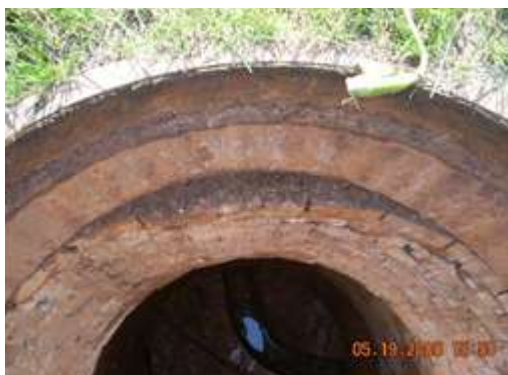
Defect 1

Offset: **1** (in.)

frame offset

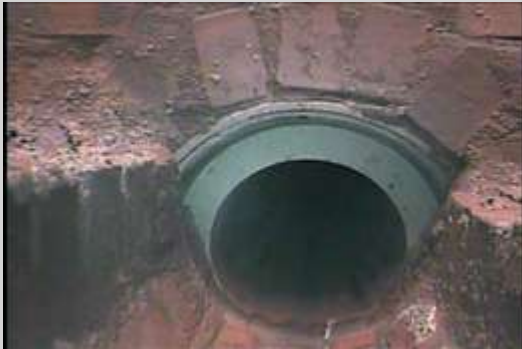
12 O'Clock Outflow

Pipe Height: **8.4** (in.) Rod and Bar (Angled)
Pipe Material: **Clay** ☐ Pipe Lined
Invert Depth: **11.00** (ft.) Flow Characteristics: **Slow**
Deposits: ☒ None ☐ Mud ☐ Sludge ☐ Debris ☐ Grease
Silt Depth: **0** (in.) Deposits Extent:
Infiltration: **None** Pipe Seal Cond: **Sound**

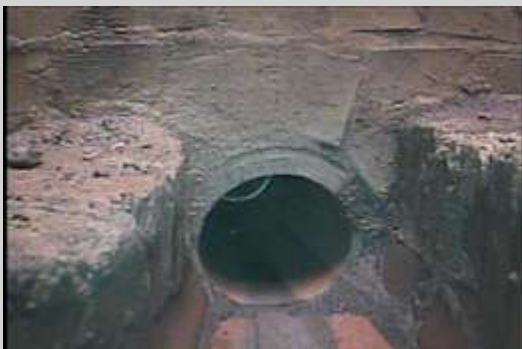
3 O'Clock Inflow

Pipe Height: **6** (in.) Rod and Bar (Angled)
Pipe Material: **Clay** ☐ Pipe Lined
Invert Depth: **10.95** (ft.) Flow Characteristics: **Slow**
Deposits: ☒ None ☐ Mud ☐ Sludge ☐ Debris ☐ Grease
Silt Depth: **0** (in.) Deposits Extent:
Infiltration: **None** Pipe Seal Cond: **Sound**
